NDI ID PA 00743

## NORTH ARROWHEAD LAKE DAM

PHASE I INSPECTION REPORT  
NATIONAL DAM INSPECTION PROGRAM

AUGUST 1981

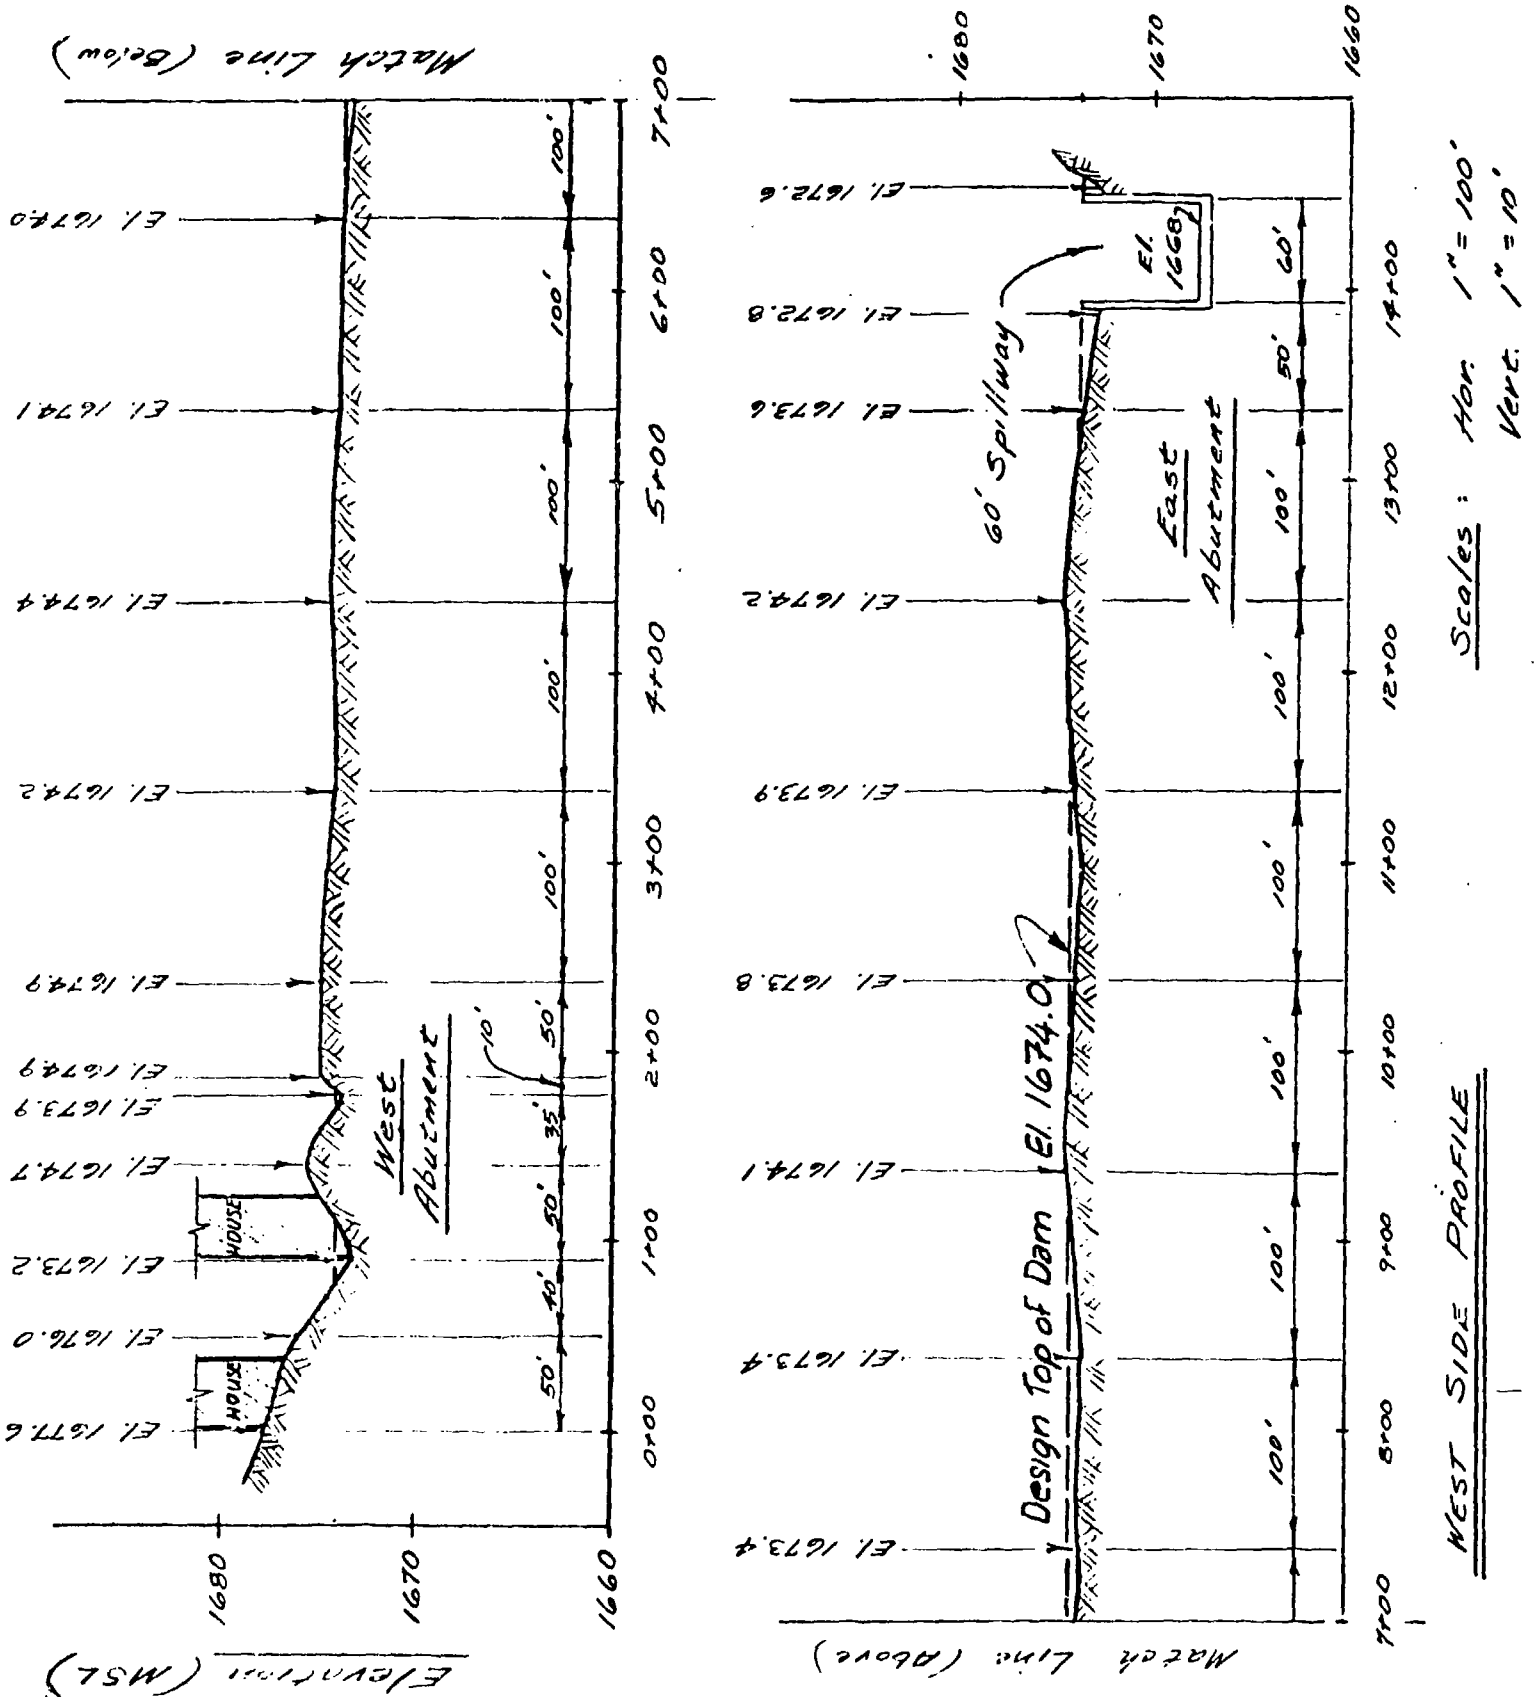
SUBJECT	SHEET	BY	DATE	JOB NO
Profile: N. Arrowhead Lake Dam	11C	ADH	4-30-81	1841.014

Low areas were observed near the west side  
abutment and on either side of the spillway  
inlet (see sheet 11C)

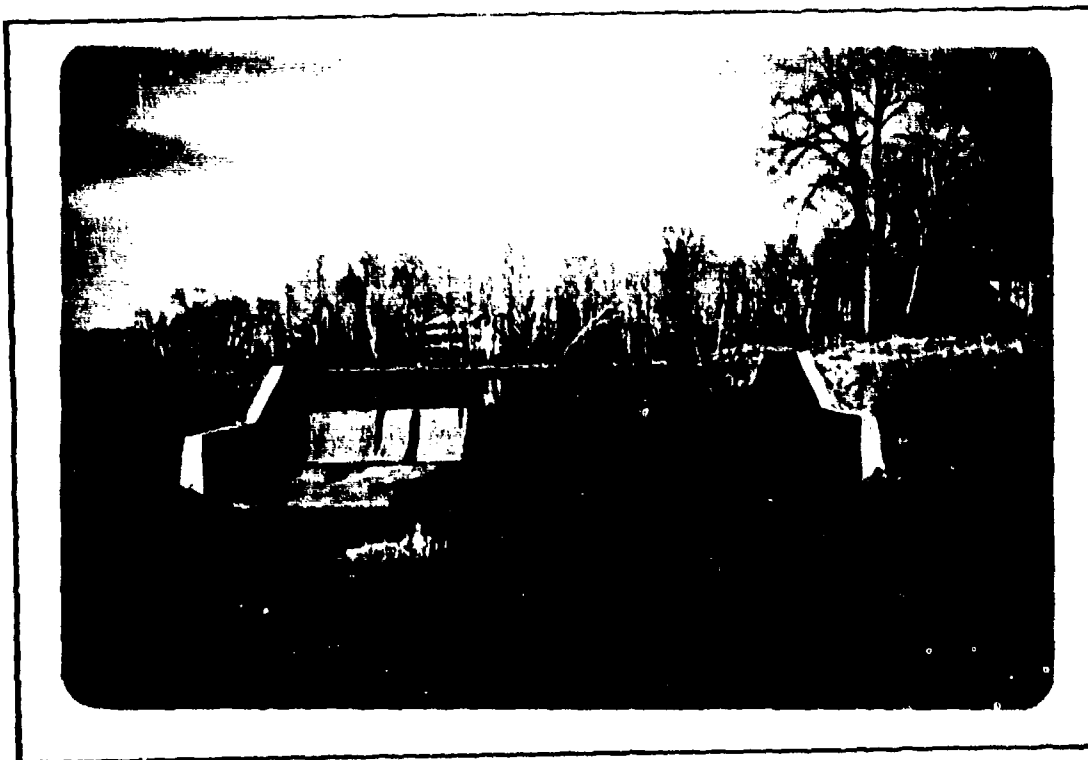
3. SPILLWAY LOOKING UPSTREAM. (4/8/81)

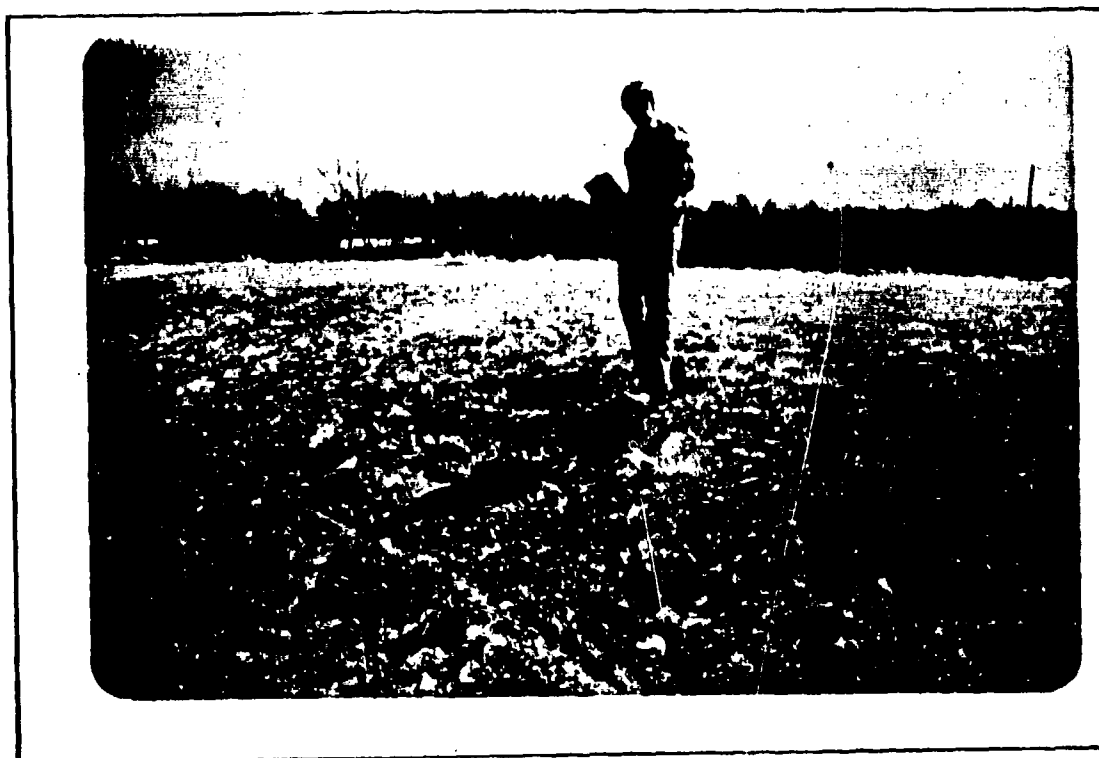
19. DISPLACED EMBANKMENT ON THE NORTH ARROWHEAD LEVEE. (4/8/81)

2. The sloughed area on the downstream slope of the levee should be repaired and monitored.
